ACTIVITY-BASED SAMPLING SUMMARY REPORT OPERABLE UNIT 4 LIBBY, MONTANA, SUPERFUND SITE

June 2, 2010

Prepared by:
U.S. Environmental Protection Agency
Region 8
Denver, CO

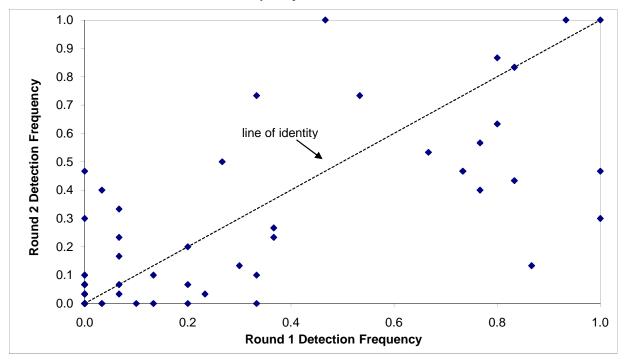
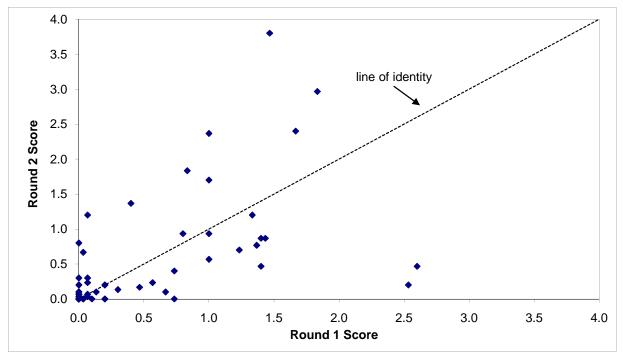
Figure 4-3
Between Round Variability in Visible Inspection Data

Panel A: Visible Vermiculite Detection Frequency

Panel B: Visible Vermiculite Weighted Score

One visible vermiculite weighted score is off-scale (Round 1 = 3.7, Round 2 = 7.5)

Restricted to 30-pt composite samples.

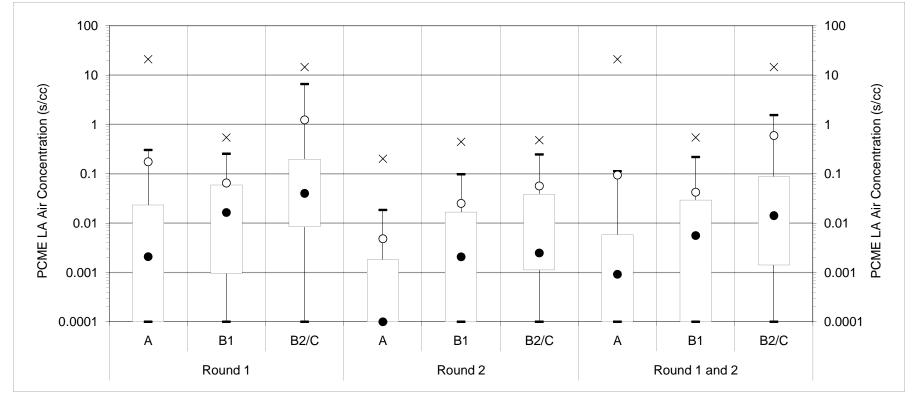
Figure 4-4. Outdoor ABS Air Concentrations Stratified by PLM-VE Results

ABS Air Data								
							P	ercentile (s/c	c)	
Round	Soil Bin	N	DF	Max (s/cc)	Mean (s/cc)	0.95	0.75	0.5	0.25	0.05
	Bin A	168	63%	21	0.17	0.3	0.023	0.0021	0	0
1	Bin B1	42	81%	0.54	0.065	0.25	0.059	0.016	0.001	0
	Bin B2/C	15	80%	14	1.2	6.5	0.2	0.04	0.0084	0
	Bin A	152	41%	0.2	0.0048	0.019	0.0018	0	0	0
2	Bin B1	55	56%	0.44	0.025	0.1	0.017	0.0021	0	0
	Bin B2/C	18	83%	0.48	0.057	0.25	0.038	0.0025	0.0011	0
	Bin A	320	53%	21	0.094	0.11	0.0058	0.00092	0	0
1 and 2	Bin B1	97	67%	0.54	0.042	0.22	0.029	0.0056	0	0
	Bin B2/C	33	82%	14	0.59	1.5	0.087	0.014	0.0014	0

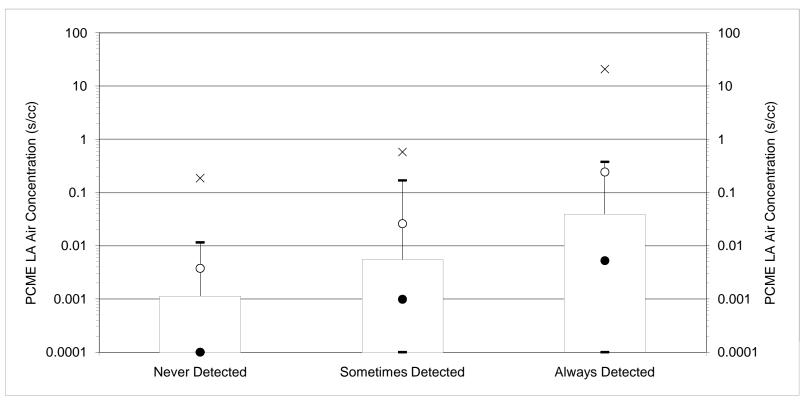
Figure 4-7. Outdoor ABS Air Concentrations Stratified by Visual Vermiculite Detection Status Across Rounds

Vis (+) = visible vermiculite was detected at one or more sampling nodes.

AB	S Air Data					
					Percentile (s/cc)					
Visible Detection Status	N	DF	Max (s/cc)	Mean (s/cc)	0.95	0.75	0.5	0.25	0.05	
Never Detected	96	39%	0.19	0.0038	0.012	0.0011	0	0	0	
Sometimes Detected	144	58%	0.58	0.026	0.17	0.0055	0.001	0	0	
Always Detected	204	67%	21	0.24	0.38	0.039	0.0052	0	0

Always Detected: The ABS area has never been ranked as non-detect by visual vermiculite estimates.

Note: Results from 1573 Kootenai River Rd are not included because visible vermiculite information was not reported in Round 1.

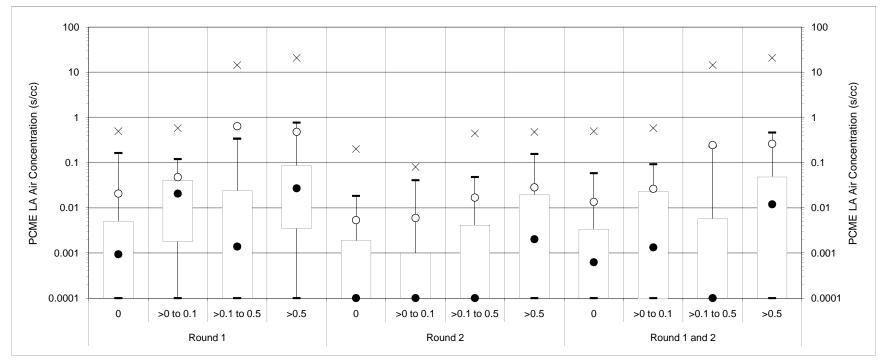
Figure 4-9. Outdoor ABS Air Concentrations Stratified by Visible Vermiculite Weighted Score Ranking

>0.1 to 0.5 visible vermiculite present in \leq 50% of visual inspection points

visible vermiculite present in more than 50% of visual inspection points

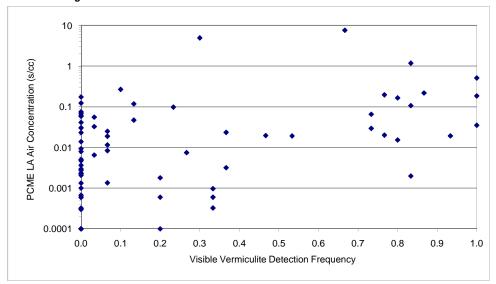
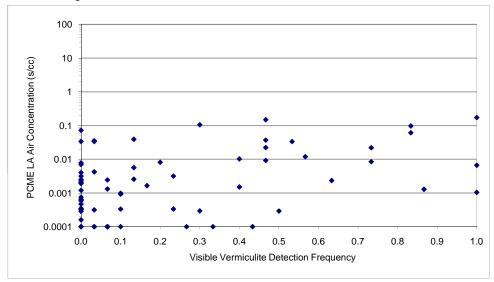
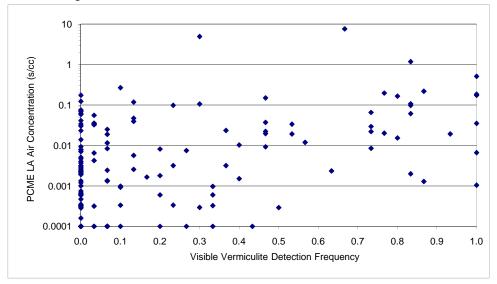
Figure 4-10. Outdoor ABS Air Concentrations as a Function of Visible Detection Frequency

Panel A: Average of all Air Concentrations Across Scenarios for Round 1

Panel B: Average of all Air Concentrations Across Scenarios for Round 2

Panel C: Average of all Air Concentrations Across Scenarios For Both Rounds

For plotting on a log scale, non-detects are assigned a value of 0.0001 s/cc (the x-axis). Average air concentrations are plotted vs. the visible detection frequency from the 30-pt soil sample.

Inspection of these graphs re-emphasizes the relative high variability in ABS air concentrations that is observed, even when variations in soil concentration are accounted for. However, despite the high variability, there is an apparent upward trend in the data as detection frequency (Figure 4-10) or visible score (Figure 4-11) increases.

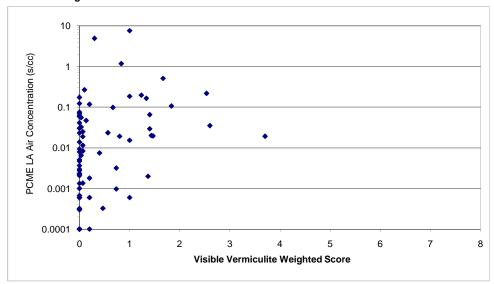
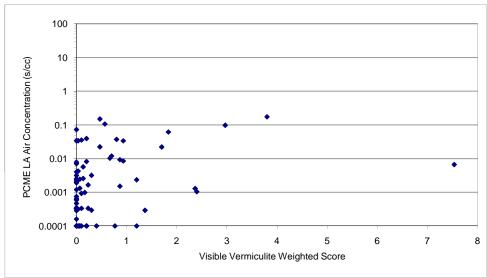
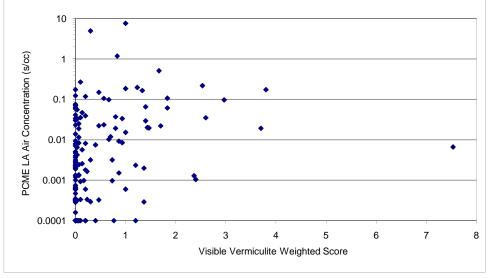
Figure 4-11. Outdoor ABS Air Concentrations as a Function of Visible Vermiculite Weighted Score

Panel A: Average of all Air Concentrations Across Scenarios for Round 1

Panel B: Average of all Air Concentrations Across Scenarios for Round 2

Panel C: Average of all Air Concentrations Across Scenarios For Both Rounds

For plotting on a log scale, non-detects are assigned a value of 0.0001 s/cc (the x-axis). Average air concentrations are plotted vs. the visible detection frequency from the 30-pt soil sample.

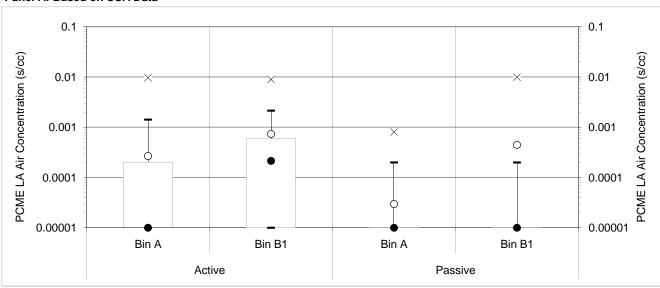
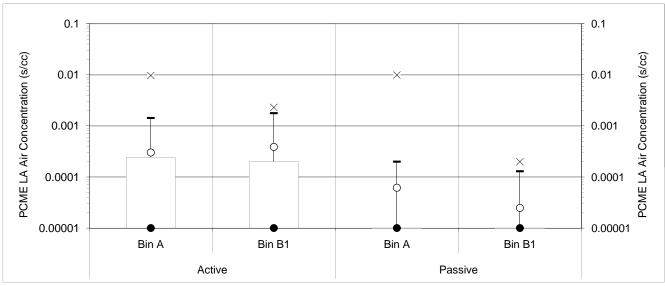
Figure 5-4. Indoor ABS Air Concentrations Stratified by PLM-VE Results

Panel A: Based on SUA Data

Panel B: Based on NSUA Data

ABS Air Data							
				Max			Pe	rcentile (s/	cc)	
Scenario	Soil Bin	N	DF	(s/cc)	Mean (s/cc)	0.95	0.75	0.5	0.25	0.05
SUA										
Active	Bin A	295	36%	0.01	0.00027	0.0014	0.0002	0	0	0
Active	Bin B1	24	58%	0.009	0.00074	0.0021	0.00059	0.00021	0	0
Passive	Bin A	296	11%	0.0008	0.00003	0.0002	0	0	0	0
rassive	Bin B1	24	21%	0.01	0.00045	0.0002	0	0	0	0
NSUA										
Active	Bin A	311	38%	0.01	0.0003	0.0014	0.00024	0	0	0
Active	Bin B1	8	25%	0.0023	0.00039	0.0018	0.0002	0	0	0
Passive	Bin A	312	12%	0.01	0.000062	0.0002	0	0	0	0
rassive	Bin B1	8	13%	0.0002	0.000025	0.00013	0	0	0	0

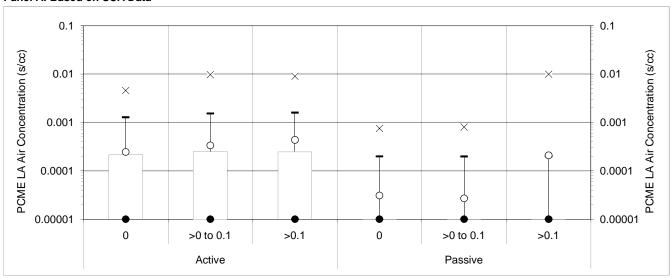
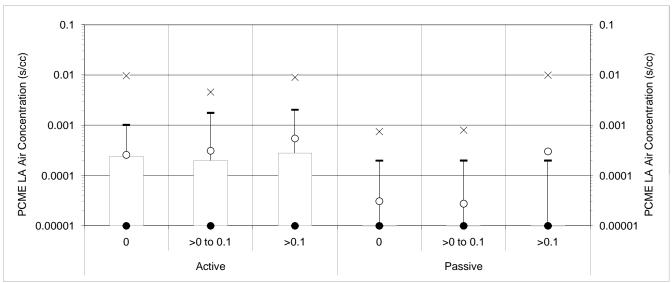
Figure 5-5. Indoor ABS Air Concentrations Stratified by Visible Detection Frequency

Panel A: Based on SUA Data

Panel B: Based on NSUA Data

ABS Air Data							
							Pe	rcentile (s/	cc)	
Scenario	DF Bin	N	DF	Max (s/cc)	Mean (s/cc)	0.95	0.75	0.5	0.25	0.05
SUA										
	0	175	37%	0.0046	0.00024	0.0013	0.00021	0	0	0
Active	>0 to 0.1	88	35%	0.01	0.00033	0.0015	0.00025	0	0	0
	>0.1	56	43%	0.009	0.00043	0.0016	0.00024	0	0	0
	0	176	12%	0.00075	0.000031	0.0002	0	0	0	0
Passive	>0 to 0.1	88	10%	0.0008	0.000027	0.0002	0	0	0	0
	>0.1	56	16%	0.01	0.00021	0.0002	0	0	0	0
NSUA										
	0	212	38%	0.01	0.00026	0.001	0.00024	0	0	0
Active	>0 to 0.1	71	31%	0.0046	0.00031	0.0018	0.0002	0	0	0
	>0.1	36	47%	0.009	0.00055	0.002	0.00028	0	0	0
	0	212	12%	0.00075	0.000031	0.0002	0	0	0	0
Passive	>0 to 0.1	72	10%	0.0008	0.000028	0.0002	0	0	0	0
	>0.1	36	17%	0.01	0.0003	0.0002	0	0	0	0

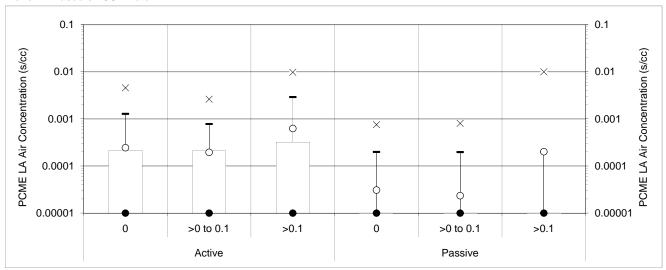
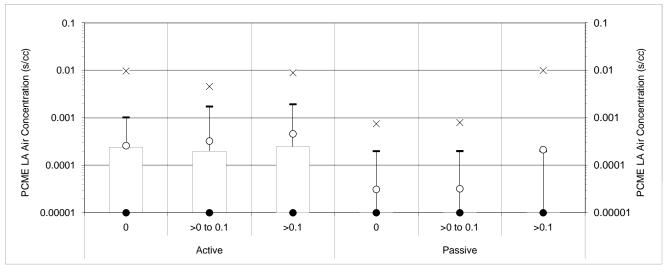
Figure 5-6. Indoor ABS Air Concentrations Stratified by Visible Vermiculite Weighted Score

Panel A: Based on SUA Data

Panel B: Based on NSUA Data

ABS Air Data							
						Percentile (s/cc)				
Scenario	Score Bin	N	DF	Max (s/cc)	Mean (s/cc)	0.95	0.75	0.5	0.25	0.05
SUA										
	0	175	37%	0.0046	0.00024	0.0013	0.00021	0	0	0
Active	>0 to 0.1	84	33%	0.0026	0.00019	0.00078	0.00021	0	0	0
	>0.1	60	45%	0.01	0.00062	0.0029	0.00032	0	0	0
	0	176	12%	0.00075	0.000031	0.0002	0	0	0	0
Passive	>0 to 0.1	84	8%	0.0008	0.000024	0.0002	0	0	0	0
	>0.1	60	18%	0.01	0.0002	0.0002	0	0	0	0
NSUA										
	0	212	38%	0.01	0.00026	0.001	0.00024	0	0	0
Active	>0 to 0.1	55	31%	0.0046	0.00032	0.0017	0.0002	0	0	0
	>0.1	52	42%	0.009	0.00046	0.0019	0.00025	0	0	0
	0	212	12%	0.00075	0.000031	0.0002	0	0	0	0
Passive	>0 to 0.1	56	11%	0.0008	0.000032	0.0002	0	0	0	0
	>0.1	52	13%	0.01	0.00021	0.0002	0	0	0	0

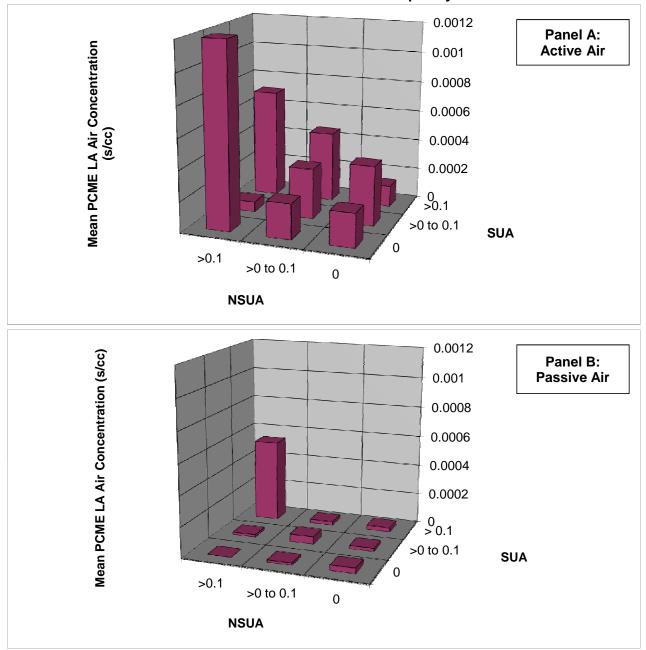
Figure 5-7. Mean PCME LA Air Concentration Stratified by NSUA and SUA Visual Detection Frequency Bins

Active Mea	n PCME LA	SUA				
Concentration (s/cc)		0	>0 to 0.1	>0.1		
	0	0.00022	0.00039	0.00014		
NSUA	>0 to 0.1	0.00023	0.00033	0.00046		
	>0.1	0.0012	0.000066	0.00071

Passive Mea	IN PCME LA	SUA				
Concentration (s/cc)		0	>0 to 0.1	>0.1		
	0	0.000035	0.000021	0.000028		
NSUA	>0 to 0.1	0.000016	0.00005	0.000025		
	>0.1	0	0.000016	0.00054

Count of	Samples	SUA				
Count of	Samples	0	>0 to 0.1	>0.1		
	0	136	56	20		
NSUA	>0 to 0.1	35	20	16		
	>0.1	4	12	20

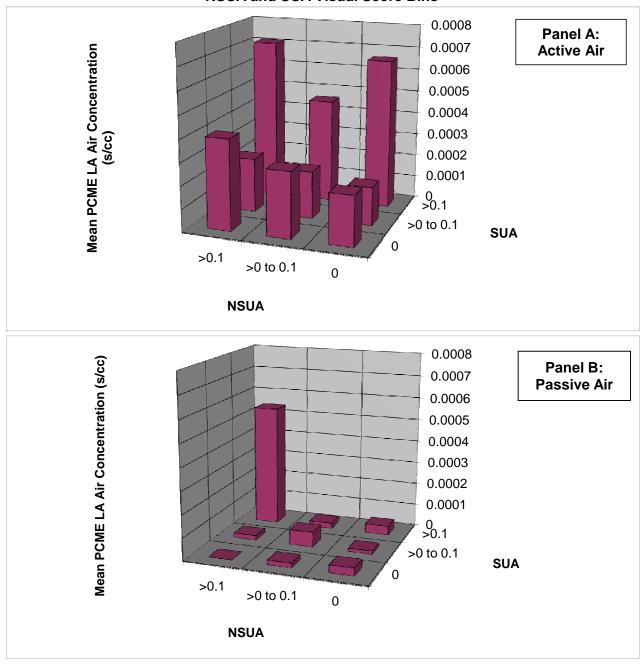
Figure 5-8. Mean PCME LA Air Concentration Stratified by NSUA and SUA Visual Score Bins

Active Mea	n PCME LA		SUA				
Concentration (s/cc)		0	>0 to 0.1	>0.1			
	0	0.00022	0.00017	0.00066			
NSUA	>0 to 0.1	0.00029	0.00021	0.00046			
	>0.1	0.0004	0.00024	0.00071

Count of Samples		SUA		
		0	>0 to 0.1	>0.1
	0	34	13	6
NSUA	>0 to 0.1	7	4	4
	>0.1	3	5	5

Passive Mean PCME LA		SUA			
Concentration (s/cc)		0	>0 to 0.1	>0.1	
	0	0.000035	0.000015	0.00004	
NSUA	>0 to 0.1	0.000021	0.000067	0.000025	
	>0.1	0	0.00002	0.00054

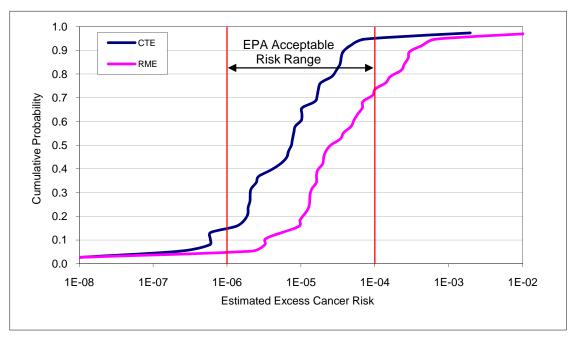
Figure 6-3. Distribution of Screening Level Total Risk Estimates^a at Properties with Both Indoor and Outdoor ABS Data

^a Total Risk = Outdoor ABS Risk + Indoor, active ABS Risk + Indoor, passive ABS Risk

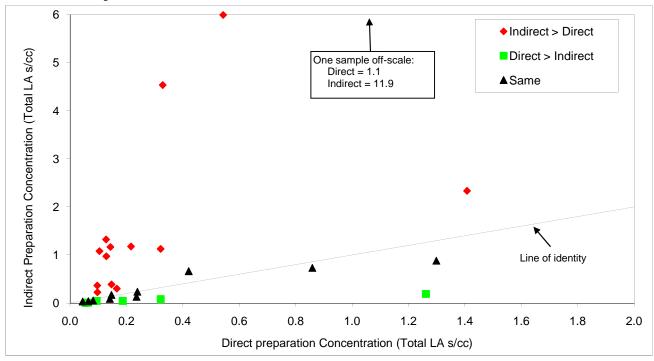
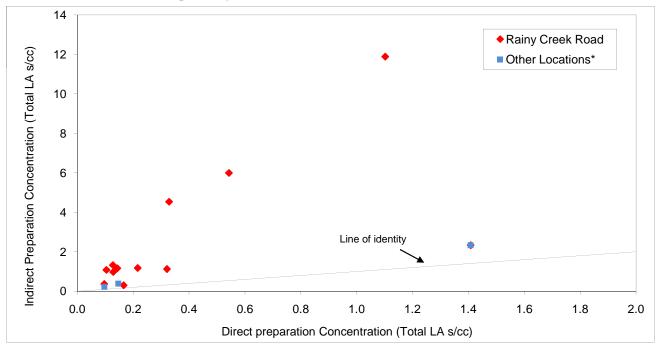
Figure 6-4. Comparison of Direct and Indirect TEM Results for 31 Air Samples from Libby

Panel A: All Samples

Panel B: Indirect > Direct Samples Only

If air samples were deemed to be overloaded, samples were prepared indirectly in accord with the procedures in SOP EPA-LIBBY-08. In brief, in an indirect preparation, rinsate or ashed residue from the original filter is suspended in water and sonicated, and an aliquot of this water is applied to a second filter which is then used to prepare a set of TEM grids. If there was no loose material present in the air cassette or adhering to the cowl, the indirect preparation method was performed as specified in ISO 13794, except that the total solution volume was increased from 40 mL to 100 mL, and a portion of the original filter was retained. If there was loose material present in the air cassette or adhering to the cowl, the indirect preparation procedure was performed as specified in ASTM D-5755, except that an ashing of the primary filter was included. A discussion of the potential influence of indirect preparation techniques on reported TEM air concentrations is presented in Section 6.4.

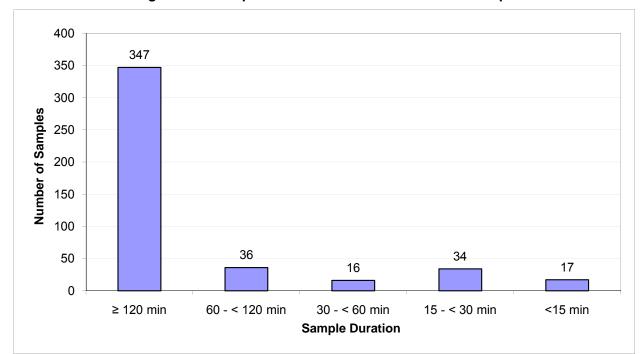
Figure 7-1. Sample Durations for Outdoor ABS Air Samples

Attributes of Short Duration (<1 hour) Samples

Sample	N Samples by ABS Scenario				
Duration	Total	Mowing	Digging	Raking	
≥ 120 min	347	115	114	118	
60 - < 120 min	36	11	11	14	
30 - < 60 min	16	4	5	7	
15 - < 30 min	34	14	12	8	
<15 min	17	6	8	3	
	450	150	150	150

Sample	N Samples by Outdoor ABS Category					
Duration	Total	EXT1	EXT2	EXT3	EXT4	EXT5
≥ 120 min	347	72	66	68	69	72
60 - < 120 min	36	9	8	5	6	8
30 - < 60 min	16	5	4	6	0	1
15 - < 30 min	34	2	7	8	9	8
<15 min	17	2	5	3	0	7
	450	90	90	90	84	96

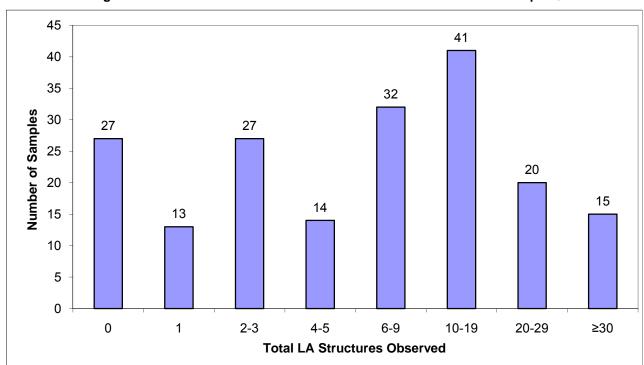
Figure 7-3. Number of LA Structures Observed in Outdoor ABS Air Samples†

† For samples where analysis was stopped based on maximum number of grid openings counted of 100.

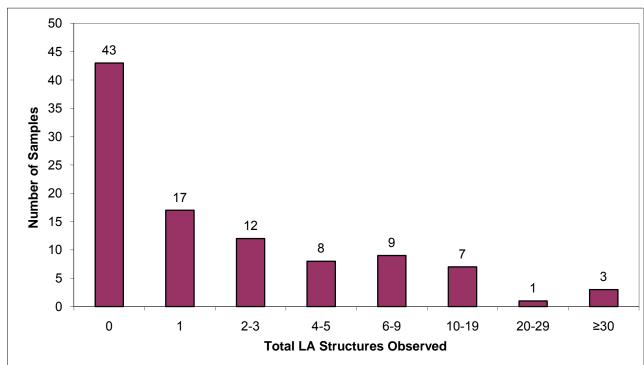
Figure 7-6. Number of LA Structures Observed in Indoor ABS Air Samples†

† For samples where analysis was stopped based on maximum number of grid openings counted of 100.
